Thermal Envelope Inspection

Building Envelope Defect Register & Severity Assessment

REPORT ID	NXS-02-SAMPLE-001	LOCATION	Calgary, AB
SITE CLASSIFICATION	Commercial — low-rise office / light-industrial · 3 storeys · ~48,000 ft ² roof	INSPECTION DATE	[SAMPLE]
FLIGHT CONDITIONS	-8 °C ambient · clear · wind < 15 km/h	PREPARED BY	Nexus Analytics
REVIEWED BY	Building Envelope Specialist	THERMAL ACCURACY	± 2 °C radiometric

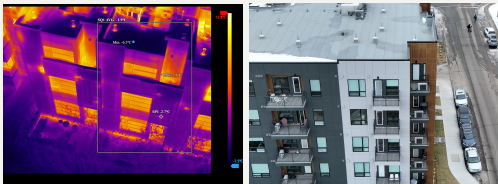
FIG. D-01 **D-01** Wet insulation (suspected, sub-membrane)

PRIORITY 1

LOCATION	Low-slope roof field, southeast quadrant
DEFECT TYPE	Wet insulation (suspected, sub-membrane)
THERMAL OBSERVATION	Irregular warm mass in the roof field, ~14 m ² , retaining heat after the surrounding membrane has cooled — the classic signature of saturated insulation below the membrane.
VISIBLE-LIGHT	No surface ponding visible at capture; defect is sub-membrane and not detectable visually.

Priority verification before next freeze cycle. Sub-membrane moisture is invisible from the surface and is one of the highest-value findings thermal imaging provides — it directly informs the roof repair-vs-replace decision. Recommend core sampling to confirm extent.

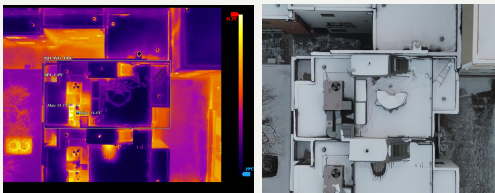
FIG. D-02 **D-02** Moisture accumulation (suspected)

PRIORITY 1

LOCATION	Parapet, northwest corner
DEFECT TYPE	Moisture accumulation (suspected)
THERMAL OBSERVATION	Distinct cool-then-slow-warming signature across a 2.3 m parapet section, characteristic of moisture retention in the assembly. Differential thermal-mass behaviour observed across the capture sequence.
VISIBLE-LIGHT	Minor membrane lifting visible at the parapet cap; consistent with a water-entry path.

Priority investigation. Suspected moisture in a parapet assembly is a freeze-thaw risk in Calgary's climate and can accelerate membrane and substrate deterioration. Recommend moisture verification and review of parapet cap flashing.

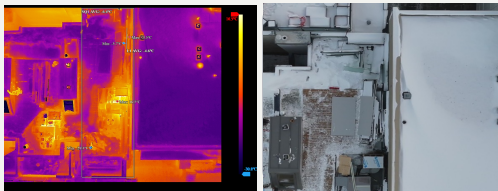
FIG. D-03 **D-03** Thermal bridging (continuous)

PRIORITY 1

LOCATION	Roof-to-wall interface, north elevation, between grids 2-4
DEFECT TYPE	Thermal bridging (continuous)
THERMAL OBSERVATION	Continuous warm signature along the roof-to-wall junction, 4.8 °C above adjacent wall surface, extending approximately 9 metres. Pattern consistent with absent or compressed insulation at the perimeter detail where the roof assembly meets the wall.
VISIBLE-LIGHT	No surface staining or mechanical source present; thermal signature is structural to the assembly, not occupancy-driven.

Prioritize for envelope review this season. Continuous perimeter thermal bridging at this scale represents persistent heat loss and elevated condensation risk at the interior junction. Recommend targeted investigation of the perimeter insulation detail.

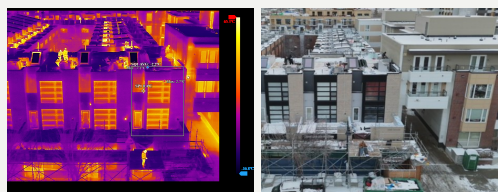
FIG. D-04 **D-04** Air leakage (perimeter)

PRIORITY 1

LOCATION	Curtain-wall / window perimeters, west elevation, floors 2-3
DEFECT TYPE	Air leakage (perimeter)
THERMAL OBSERVATION	Repeating warm plumes at window head and jamb perimeters across multiple bays, 3.2-4.1 °C above field wall temperature, with the characteristic fan-shaped pattern of air exfiltration.
VISIBLE-LIGHT	Aged perimeter sealant visible at several bays; consistent with a degraded air seal.

Plan a perimeter sealant renewal program for the west elevation. The repeating pattern across bays indicates a systemic detailing/aging issue rather than isolated failures, which makes a coordinated program more cost-effective than bay-by-bay repair.

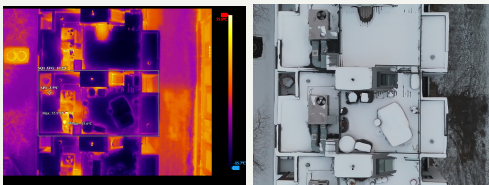
FIG. D-06 **D-06** Penetration sealing (minor)

PRIORITY 2

LOCATION	East elevation, mechanical penetration cluster
DEFECT TYPE	Penetration sealing (minor)
THERMAL OBSERVATION	Localized warm points at three exterior penetrations, 2.0-2.6 °C above field, consistent with minor air leakage at the seal.
VISIBLE-LIGHT	Penetration seals visibly aged but intact.

Address opportunistically during the next maintenance cycle. Low-cost seal renewal; not urgent.
